Docket No. 217 - Development and Management Plan Inspection

Northeast Utilities Service Company Certificate of Environmental Compatibility and Public Need for the construction of a 345-kV electric transmission line and reconstruction of an existing 115-kV electric transmission line between Connecticut Light and Power Company's Plumtree Substation in Bethel, through the towns of Redding, Weston, and Wilton, and to the Norwalk Substation in Norwalk, Connecticut.

Date: October 13, 2006

Location: 115 kV Underground Route

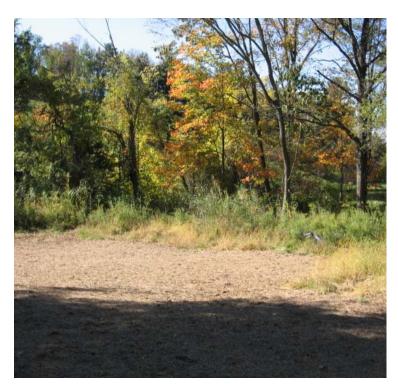
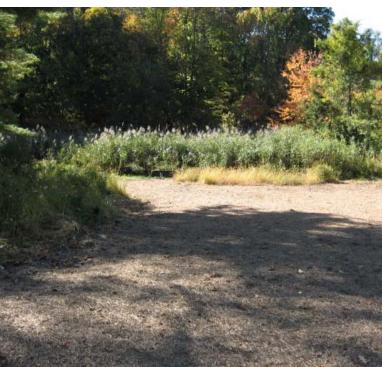
Both photos shows the Redding CC storage yard following restoration efforts. Stone was removed and the area was loamed, seeded and mulched. Wetlands are present in the background, beyond the silt fence. 10/13/06

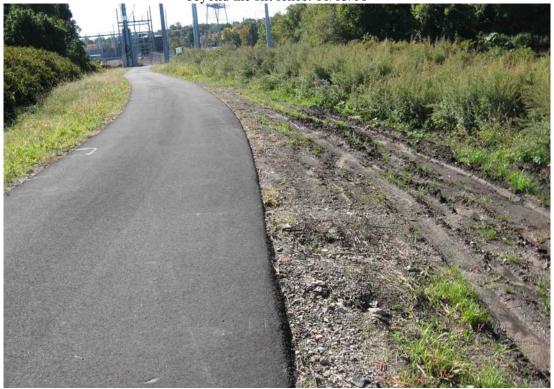
Photo shows a view of the bike path. Adjacent areas will be restored following repairs to the asphalt. Remaining silt fence debris should also be removed from under the soil. (This may occur as work under another section of the project.) 10/13/06

- The area adjacent to the bike path off Broad St is one remaining area that could use additional restoration. 10/4-10/12/06	- Continue to restore/revegetate and if feasible. 10/04-10/13/06	-Contractors are scheduled to reseed the area.
Dewatering	- Dewatering is no longer necessary at this time. 10/13/06	-None at this time. 10/13/06	-N/A
Spills and Material Storage	- Few, if any vehicles remain in this section of the project. 10/13/06	- Do not perform any refueling or equipment maintenance when wetlands or waterways are adjacent. 6/1-10/13/06	-N/A at this time
Additional Observations	- This section could be removed from the inspection route shortly 10/13/06
